CAFO FACILITY INSPECTION REPORT

INSPECTOR(S): Anthony D'Angelo (PG Environmental, LLC)

04/11/2013
ACTUAL INSPECTION DATE

TIVA Dairy
FACILITY NAME

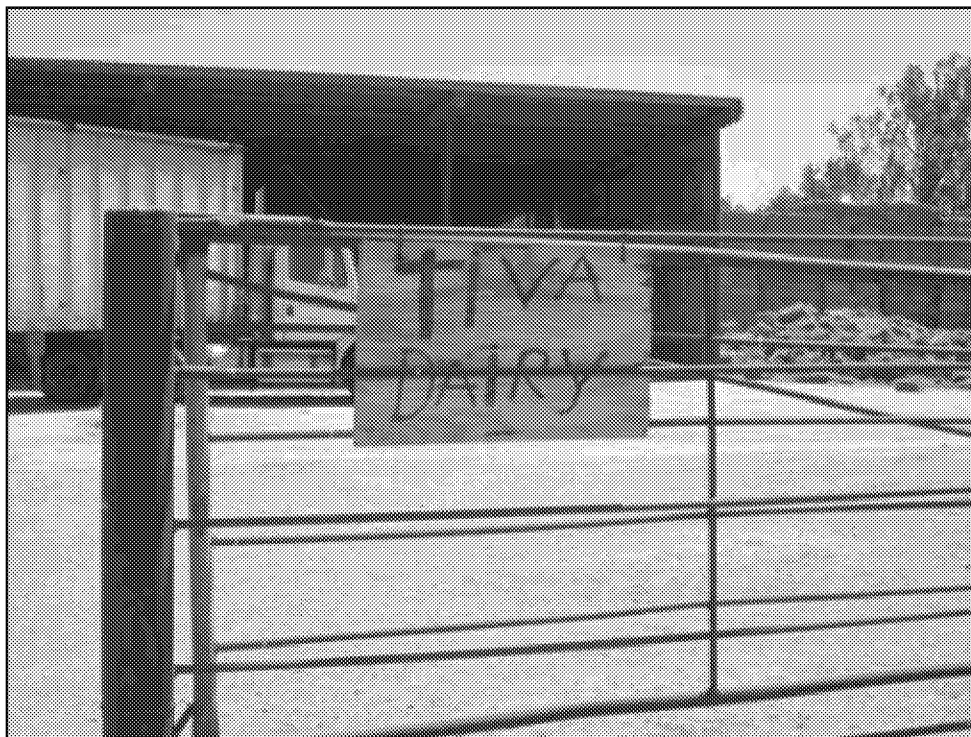
Photograph 1. TIVA Dairy Facility sign.

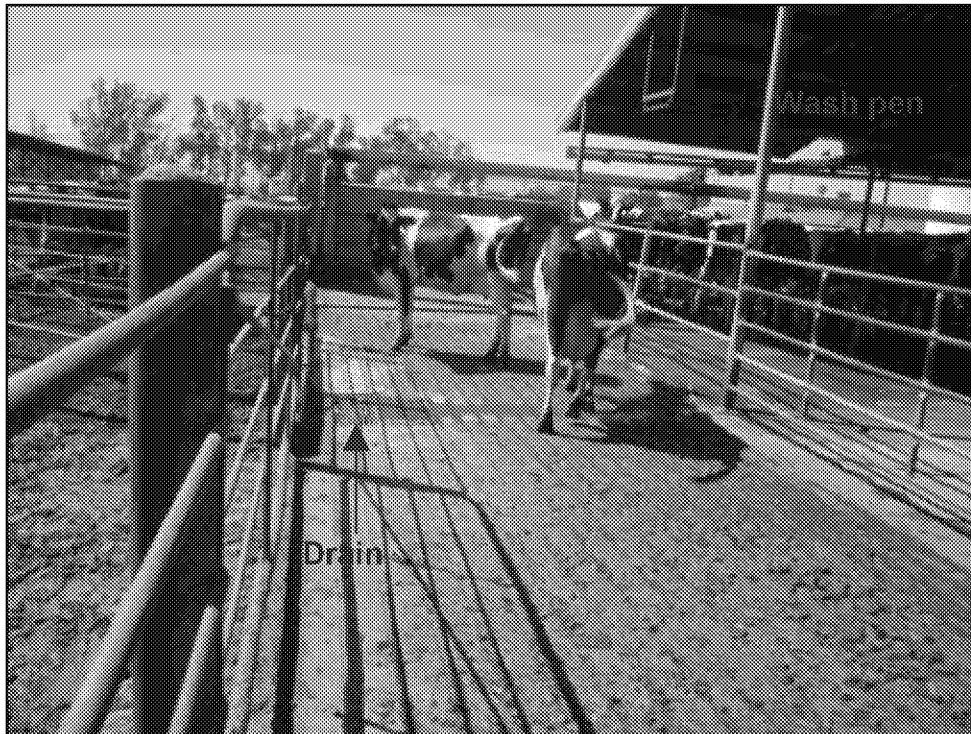
Photograph 2. View facing south of the wash pen drain on the east side of the milking barn. This drain conveys process wastewater to a standpipe located in the southwest portion of the Facility.

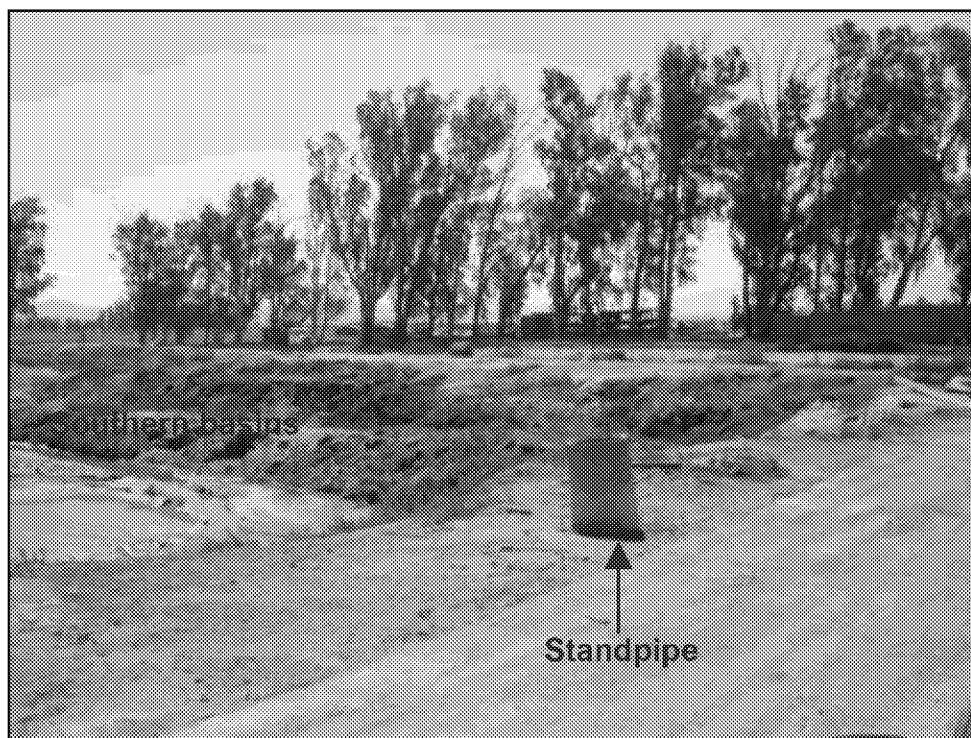
Photograph 3. View facing southeast of the process wastewater standpipe located on the west side of the southern basins. The standpipe conveys process wastewater to four (4) check valves on the west side of the southern basins.

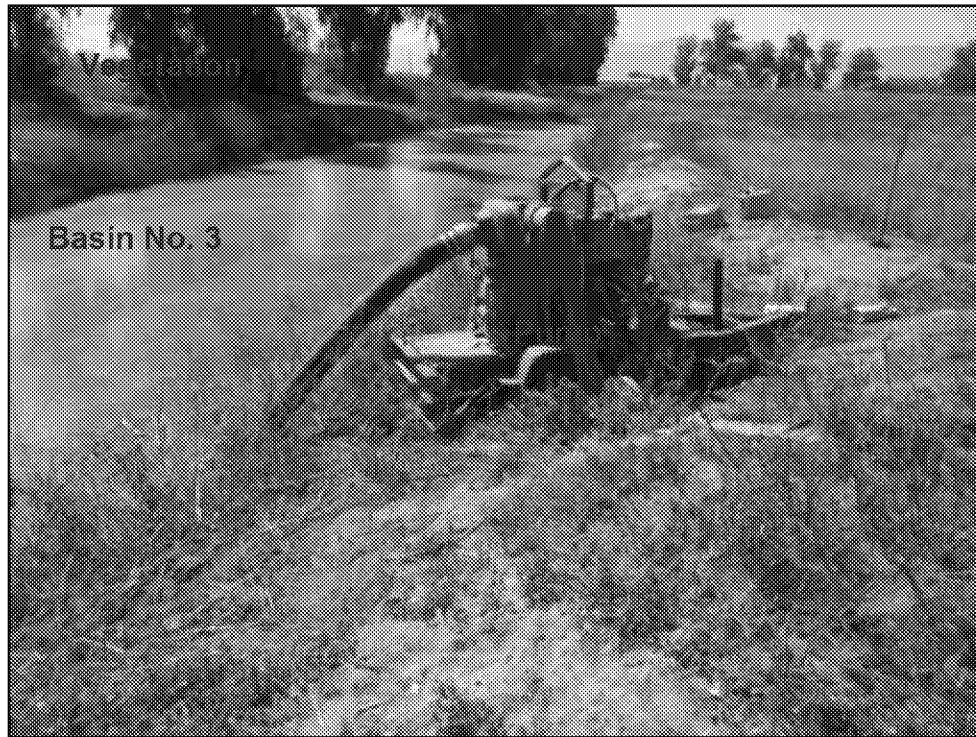
Photograph 17. View facing south of a pump located at basin No. 3. Note the pump is used to transfer process wastewater from the basin onto field No. 3 for land application/disposal.
